CITY OF WHITTIER DELONG DOCK

2018 Condition Inspection Report

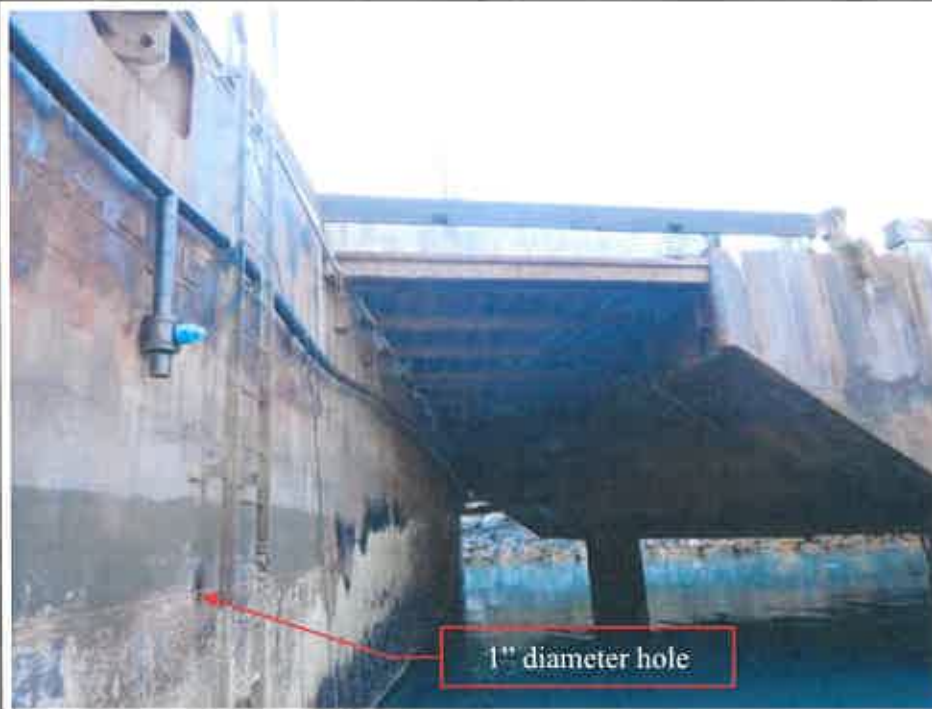
Photo # 5

- Two (2) small diameter holes were found on the stern of the eastern barge (Photo 5). It is unknown if these were intended drain holes or areas of significant corrosion and section loss. It is recommended this area be monitored in future inspections for accelerated corrosion.

Transition bridge between barges.

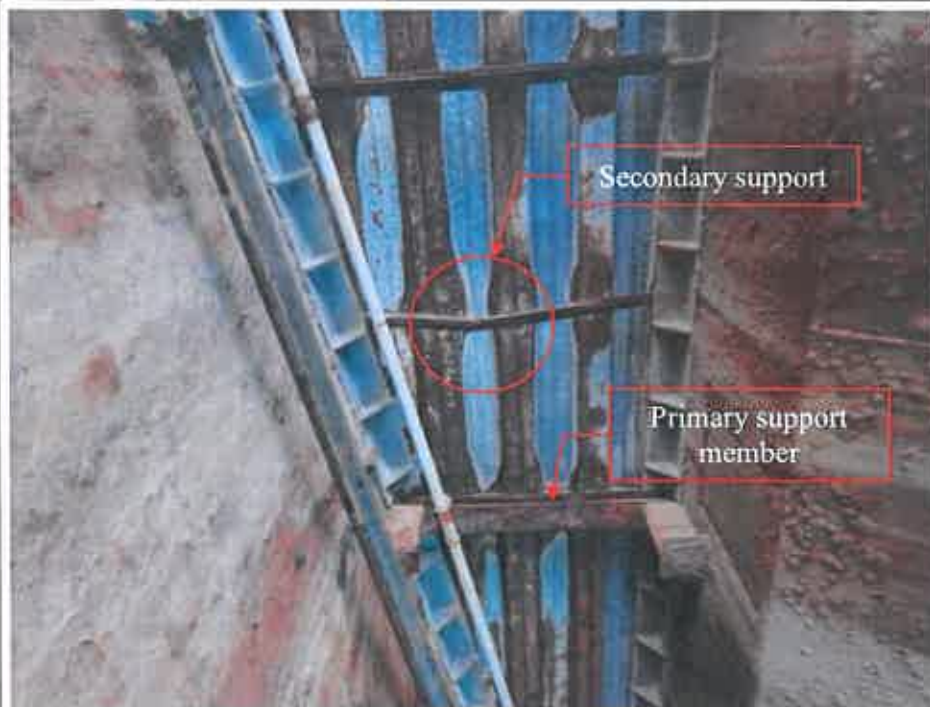
Photo # 7

Damaged secondary support member.

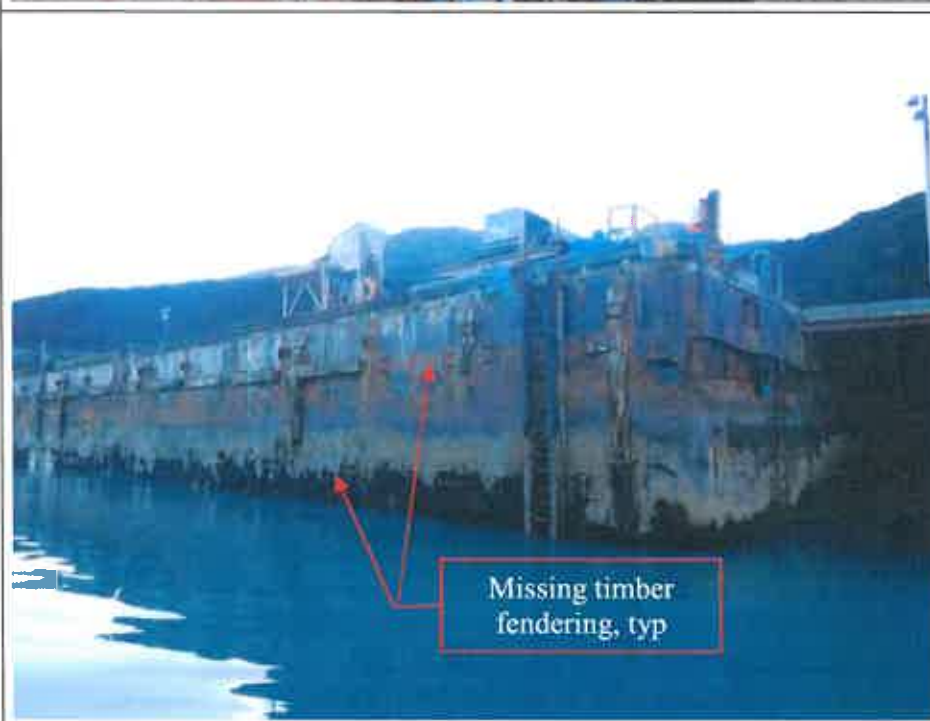
Photo # 8

East Barge looking south.
(Note deteriorated and missing fendering)

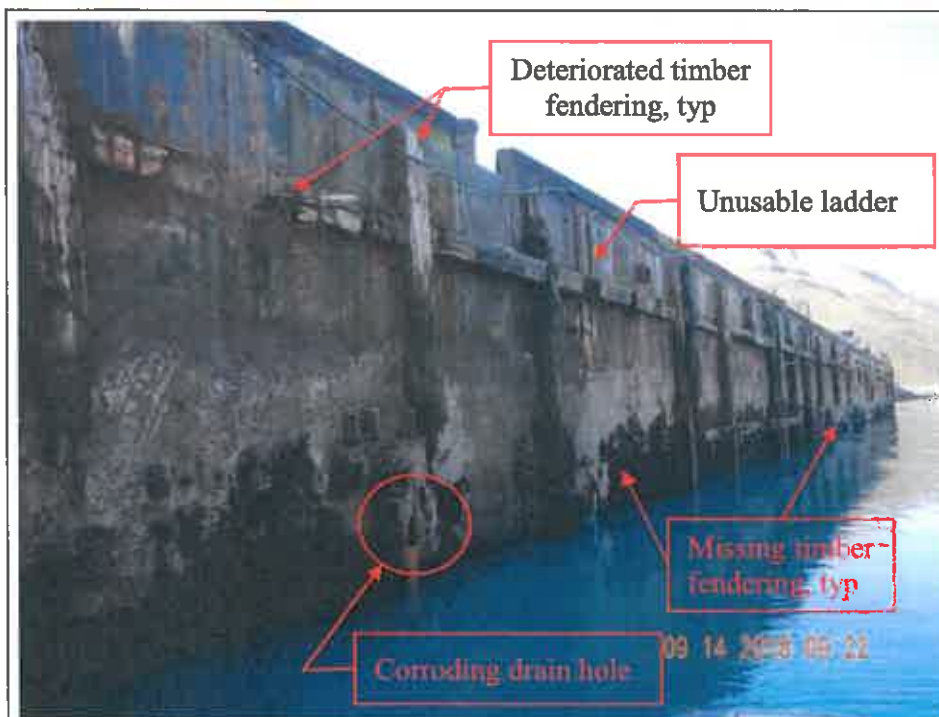
**Photo # 9****Description:**

North face of east barge looking west.
(Note enlarged drain hole and deteriorated timber fendering)

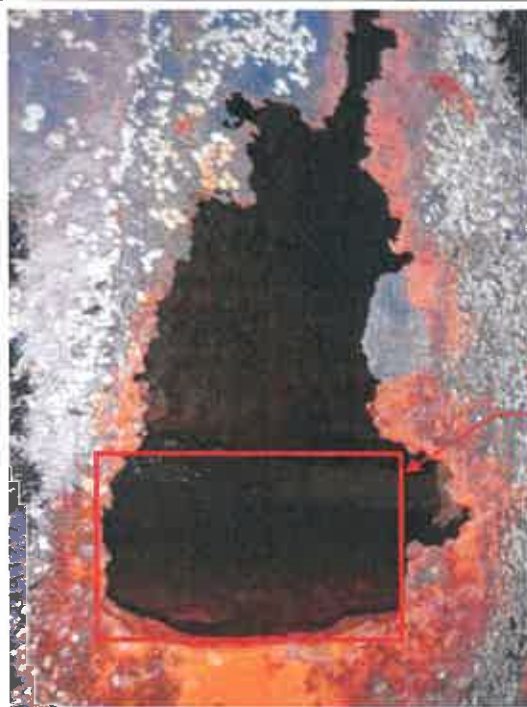
**Photo # 10****Description:**

- One (1) large diameter drain hole on the north face of the eastern barge had 100% section loss over a 6"x12" area (Photo 10). This is more corrosion observed than at any other drainage hole. As recommended in 2014, installing or restoring the cathodic protection system would minimize further deterioration of the barge hull.

Significant corrosion around drain hole.

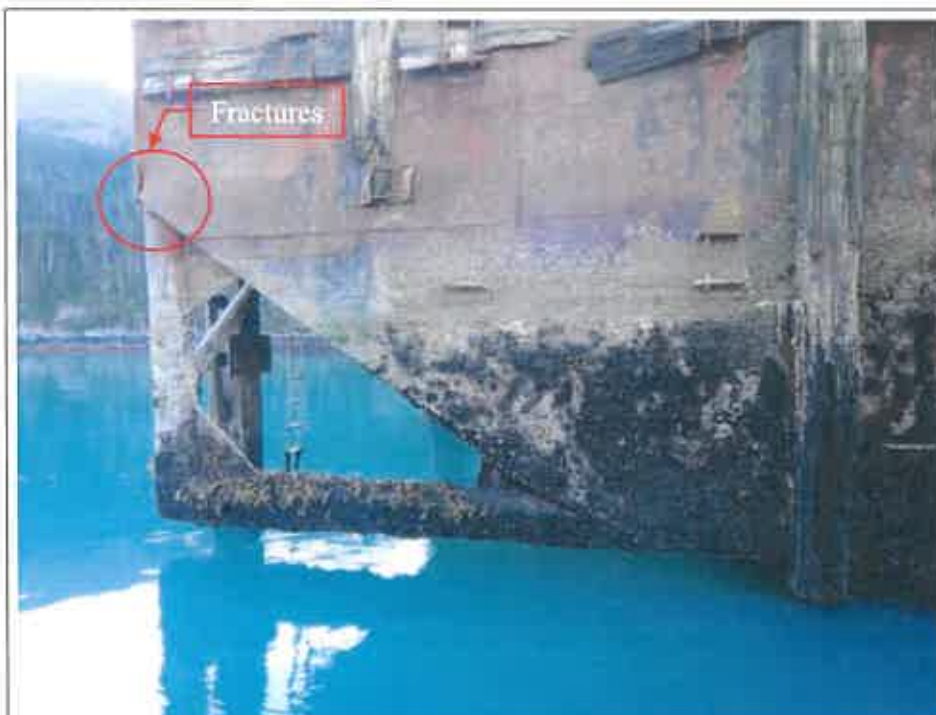
Photo # 11

- The north pipe brace on the eastern barge rake is cracked in multiple locations, likely due to vessel impact (Photo 11-12). If the eastern and northern faces of the barge are going to be utilized for future mooring and berthing, it is recommended these cracks be repaired. Otherwise, these may be left in their current condition as they do not provide any significant structural benefit.

Pipe bracing on rake of eastern barge.

(Note steel fractures at top connection)

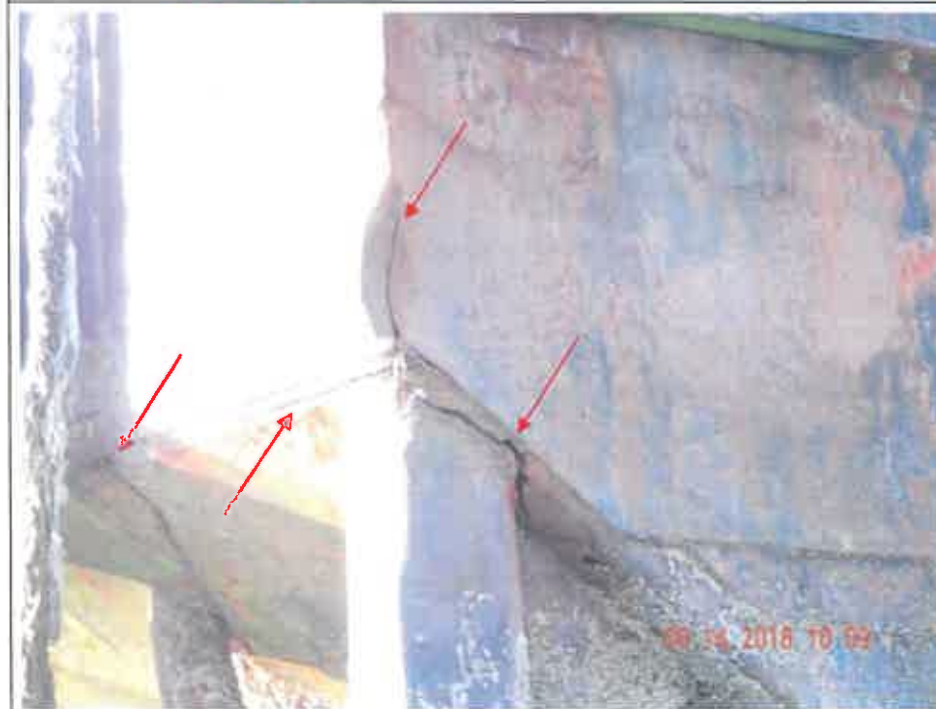
Photo # 12

Steel fractures around rake pipe bracing.

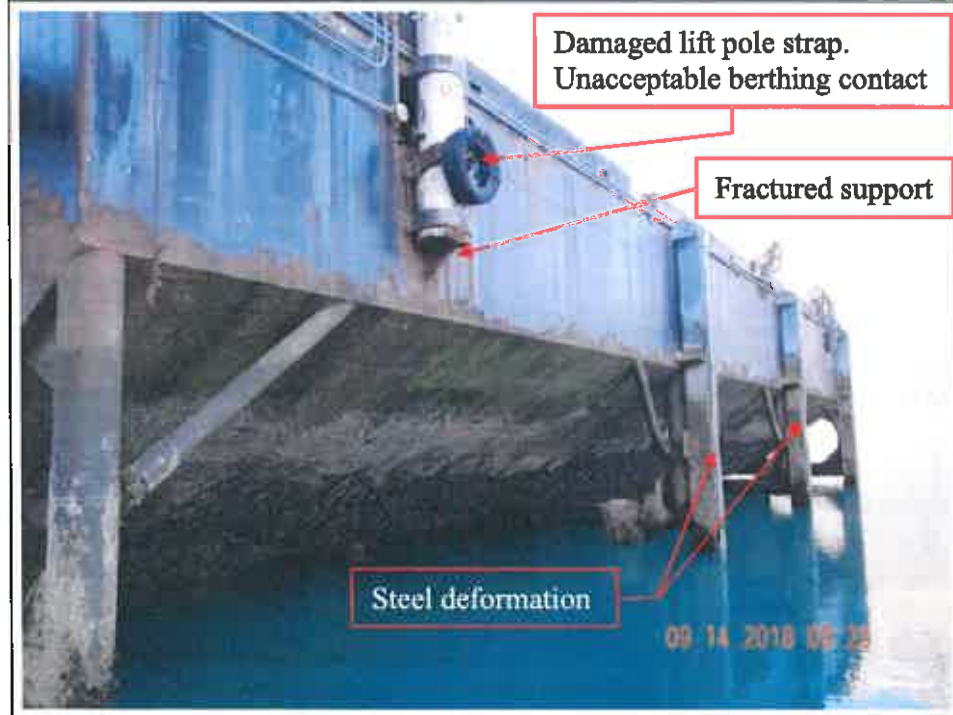
<p><u>Photo # 14</u></p> <p><u>Description:</u></p> <p>East barge bow looking north.</p>

- It appears the light pole on the eastern face of the east barge has been used as a mooring point for vessels (Photo 14). This is an unacceptable berthing point and could severely affect the structural integrity of the light pole and/or its attachments if impacted. This is likely the cause for the damaged steel strap and fractured steel support. Timber crushing was also observed at the butt of the pole. Any intended berthing on this face should be done so as to not come in contact with the any of the light pole components. If future berthing on this face is desired, it is recommended the steel framing or large fenders be installed around the light pole to prevent any vessel contact with the timber and its supporting components. The steel strap should be replaced in-kind and supporting steel seat be repaired by welding new steel plate around the damage. A thorough

investigation of remaining components is recommended as the noted observations were made from a distance and additional deficiencies may be present.

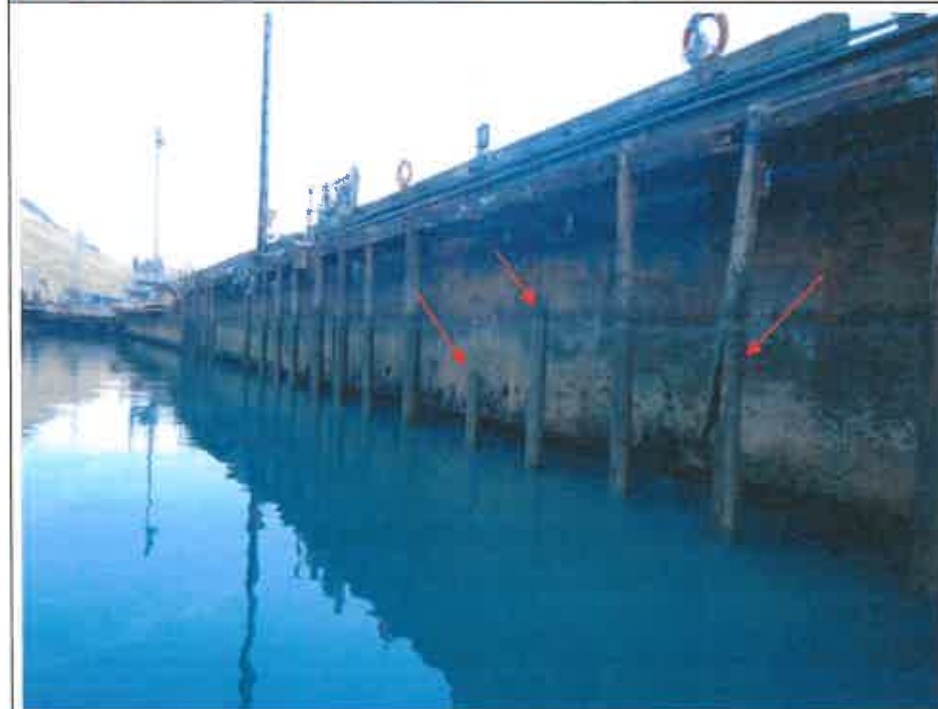
Photo # 16

- The timber pin pile and blocking are generally in need of replacement. Six (6) of twenty-nine (29) pin pile are broken or otherwise missing (Photo 16-17). The majority of the remaining pile have

Broken timber fenders on south face of East barge.

moderate to severe damage at the waler connections (Photo 18). It is recommend all of the pin pile and timber blocking be replaced in-kind assuming future use is from light commercial vessels only. The rubber fender elements and timber waler are in fair condition with appreciable light commercial service life remaining.

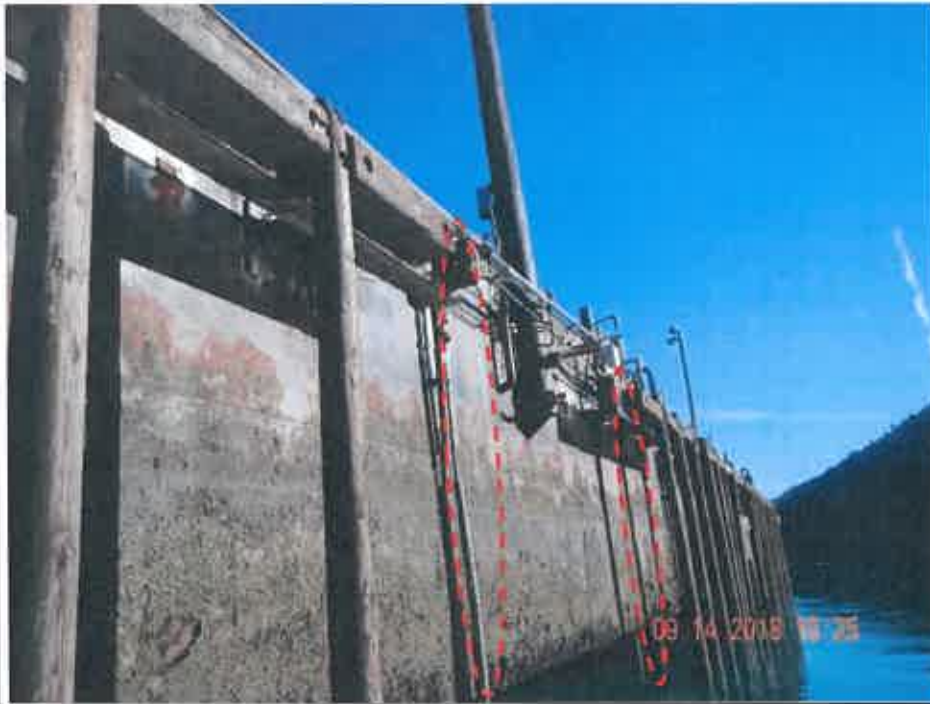
Photo # 17

Missing timber fender pile.

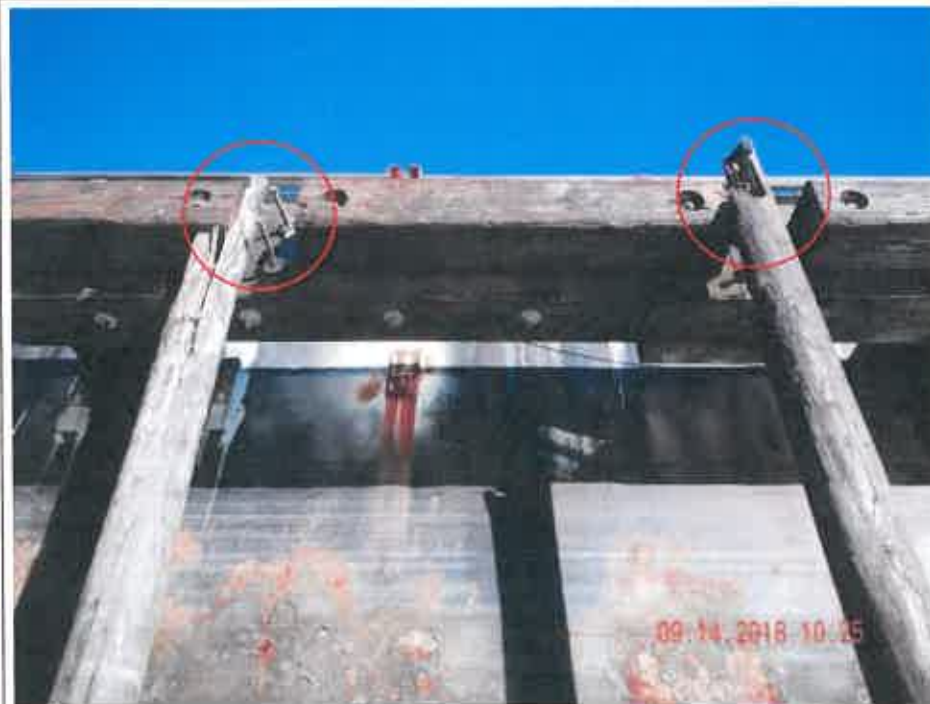
Photo # 18

Typical damaged to timber fender pile connections.

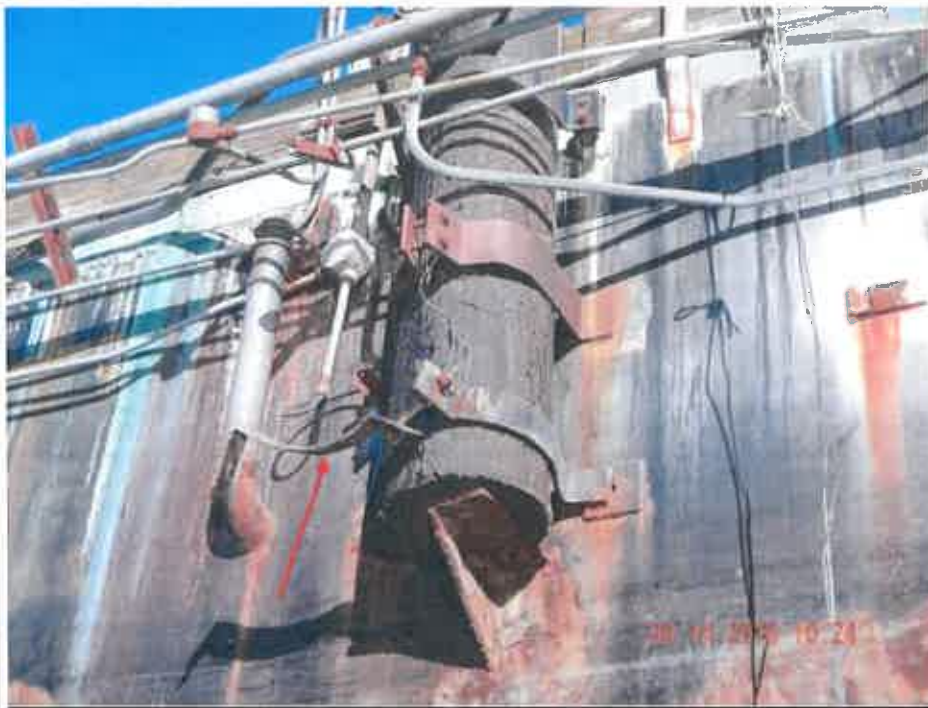
Photo # 19

- The light pole on the pole near bent 15 has damaged steel straps that should be replaced immediately as they are the primary tie-downs for wind loads (Photo 19).

Damaged strap on light pole, south face of east barge.

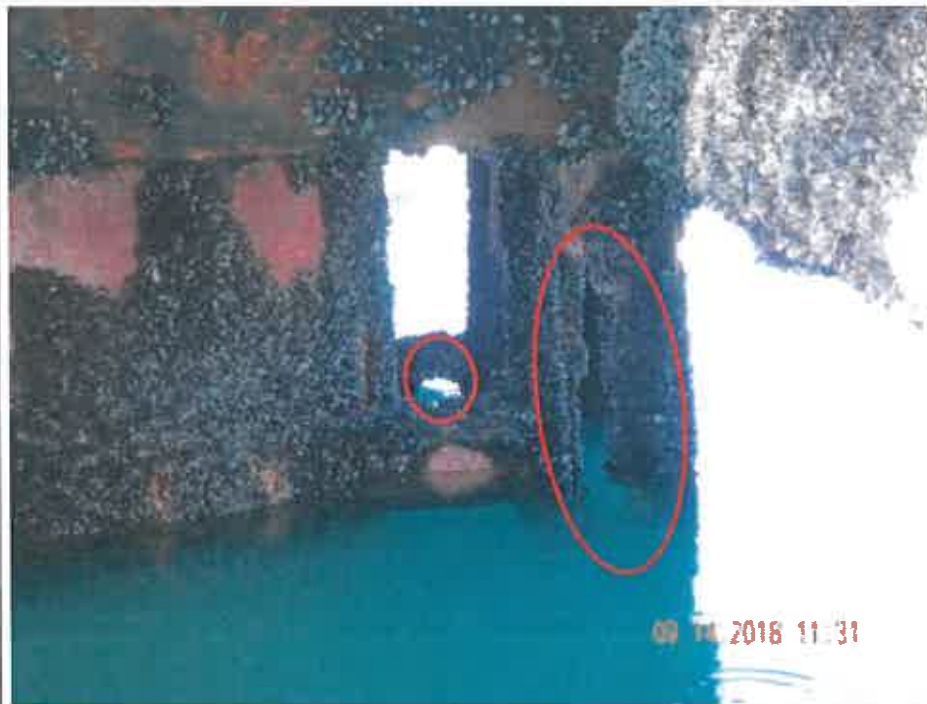
**Photo # 21****Description:**

- Pile knee bracing is typically observed having 100% section loss of the webs (Photo 21). The original intent of these braces is unknown. It is possible these were utilized during construction and have no structural relevance. The available design drawings have no reference of these either. It is likely these braces have been deteriorated for much of the 65-year-old dock's life and there appears to be no indications of load path failures or damage to the hull. Therefore, it is recommended these braces be left as-is and monitored in future inspections. However, for reference, PND has provided a cost estimate for replacing all these members in Section 4.0.

Pile knee bracing with 100% section loss in webs, typ.

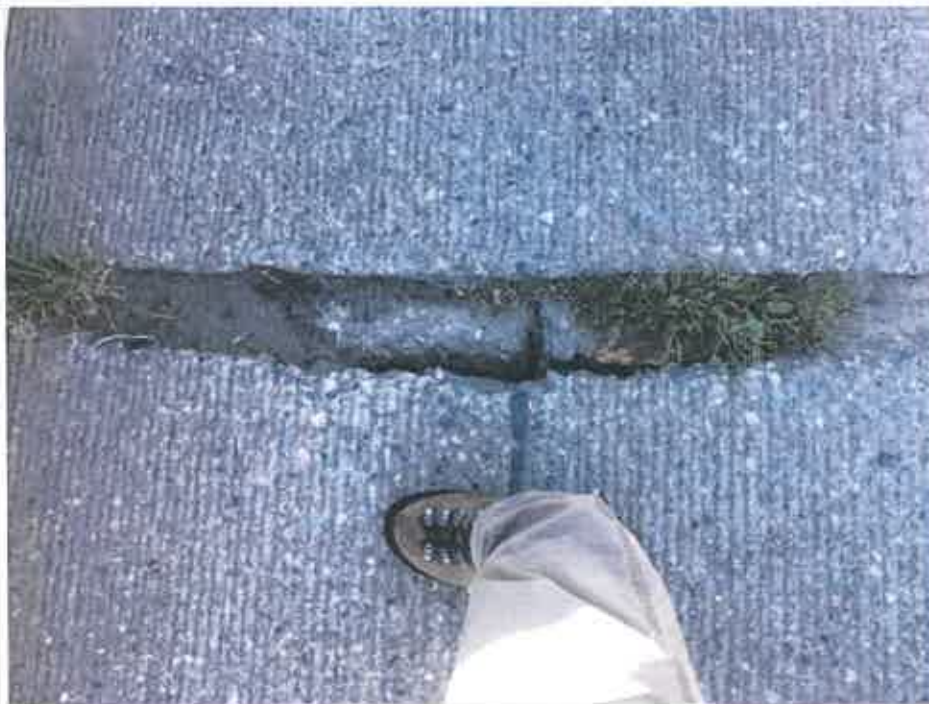
Photo # 24

Transition bridge joint cracking.

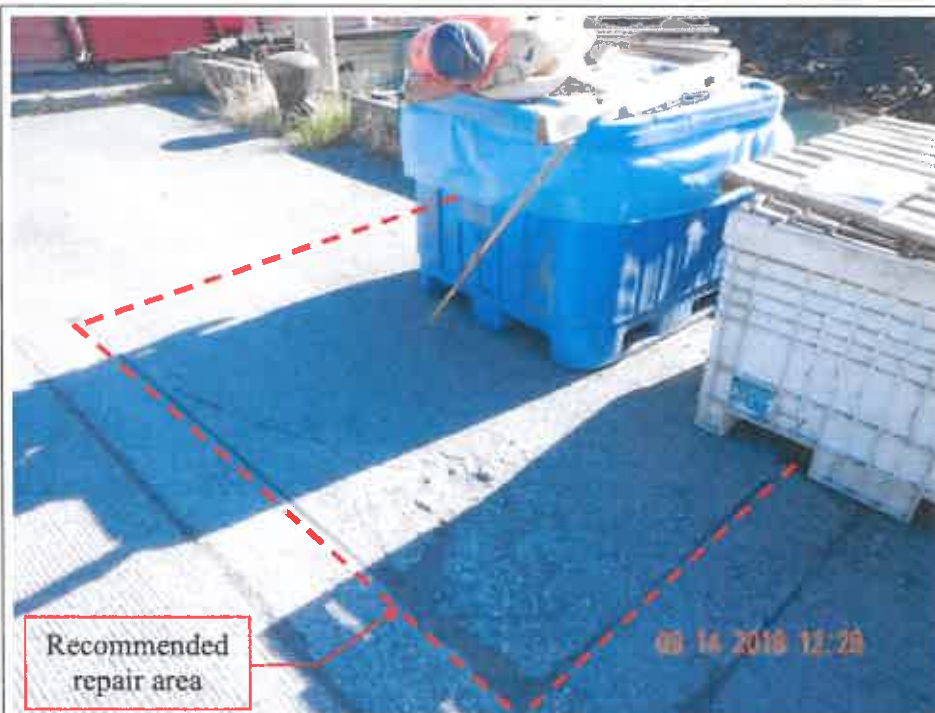
Photo # 25

- A patch on the western barge is experiencing severe cracking and spalling (Photo 25). Surrounding concrete sounds hollow indicating a poor bond to the subsurface and higher likelihood for future spalling. The deteriorating concrete should be removed and patched.
- The transition bridge slab is also seeing signs of distress along the constructing joints where the joint filler has deteriorated (Photo 23-24). The joint should be cleaned out and sealed to prevent dirt, moisture, and vegetation from growing in this area.
- Some of the secondary supports beneath the transition bridge slab were found bent, and one (1) fractured (Photo 7). These members were likely placed to support the corrugated steel pan decking during the initial slab pour. The adjacent primary support beams appear to be in fair condition. Therefore, repairs are not recommended at this time.

Cracking/ spalling on slab patch of west barge.

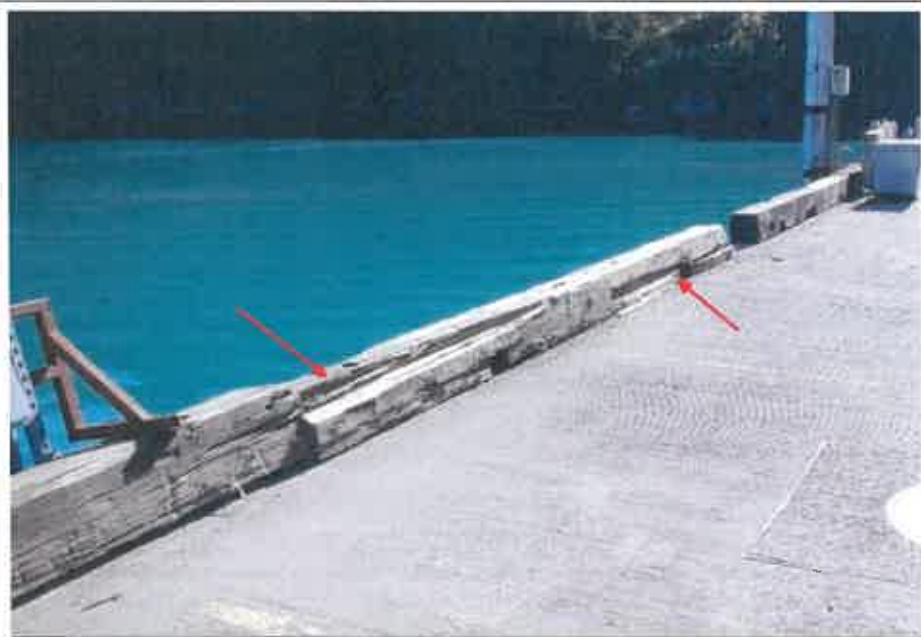
Photo # 26

- Splitting, rotting, or otherwise deteriorated timber throughout the perimeter of the dock was observed (Photo 26-27). Replace timbers in-kind. The majority of the attachment hardware are in good condition and are likely reusable for the new timber.
- Two (2) bullrail locations on the north face of the east barge are in need of bolt replacement (Photo 28). The timber rail appeared to be in good condition and may be reused.

Deteriorated timber bull rail on east edge of east barge.

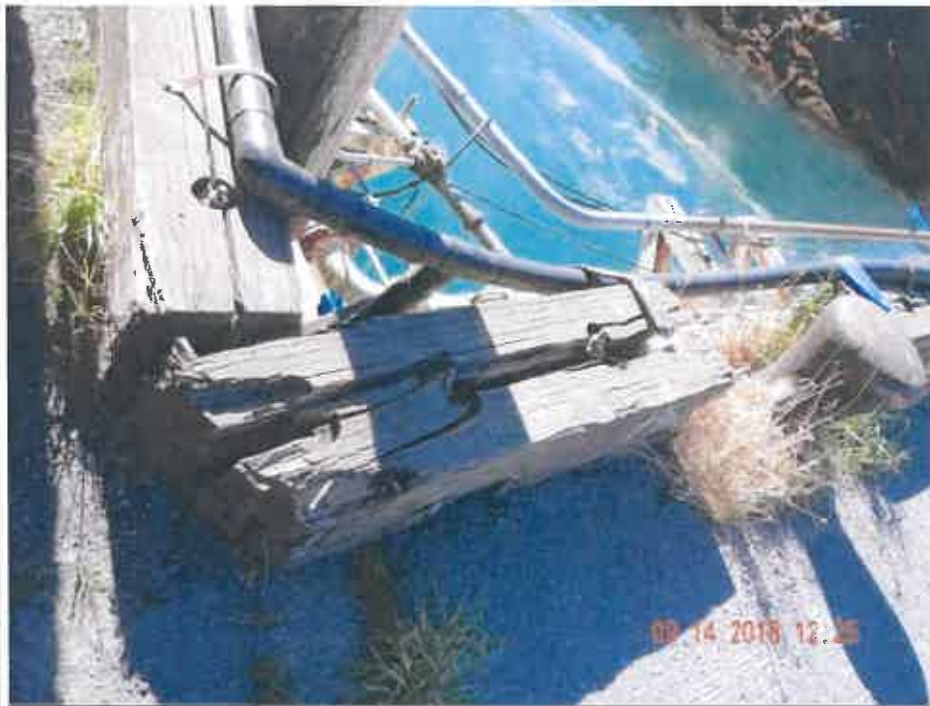
Photo # 27

Typical damaged/deteriorated bullrail.

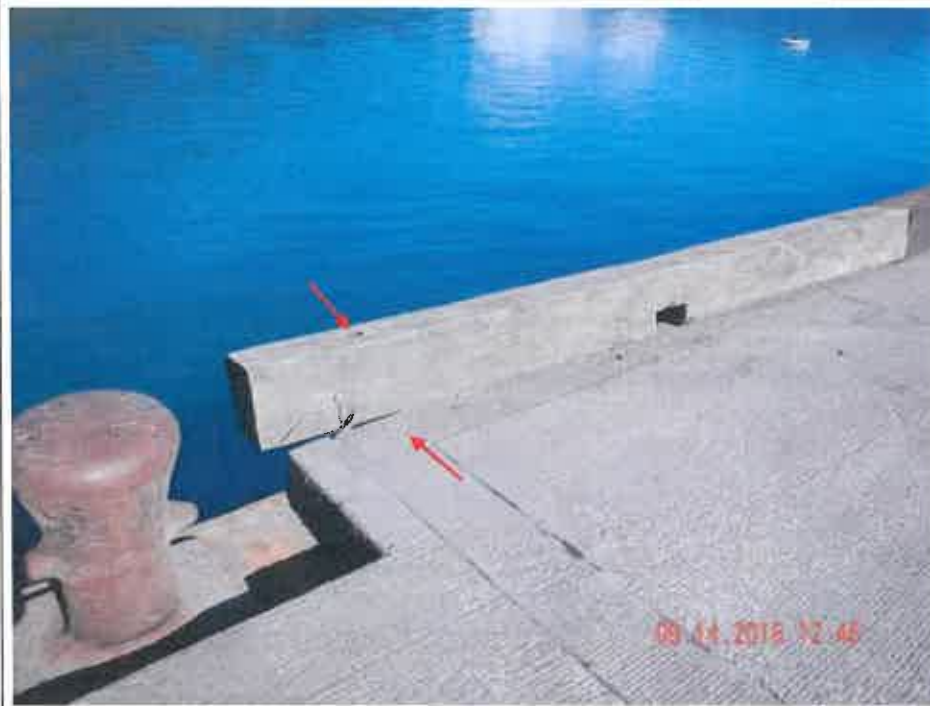
Photo # 28

Sheared bullrail bolt on north edge of east barge.

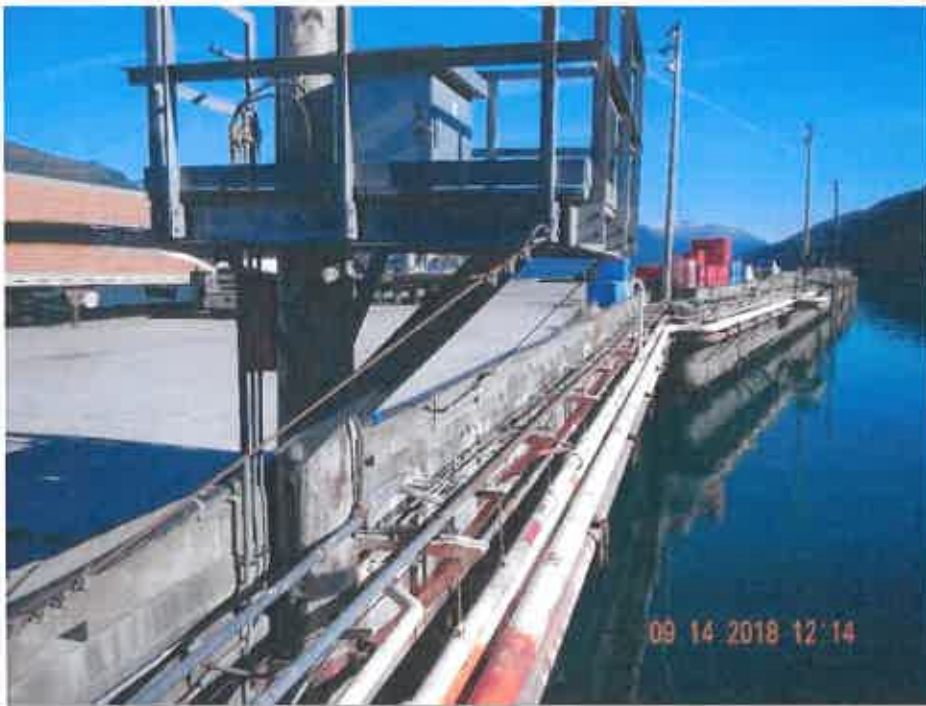
Photo #29

- Piping, electrical and impressed current systems, though outside of PND's scope, appeared abandoned and unserviceable (Photo 29). It is recommended these be tagged or removed to minimize confusion and safety risks in case some utilities are still active.

Abandoned utility piping on south face.

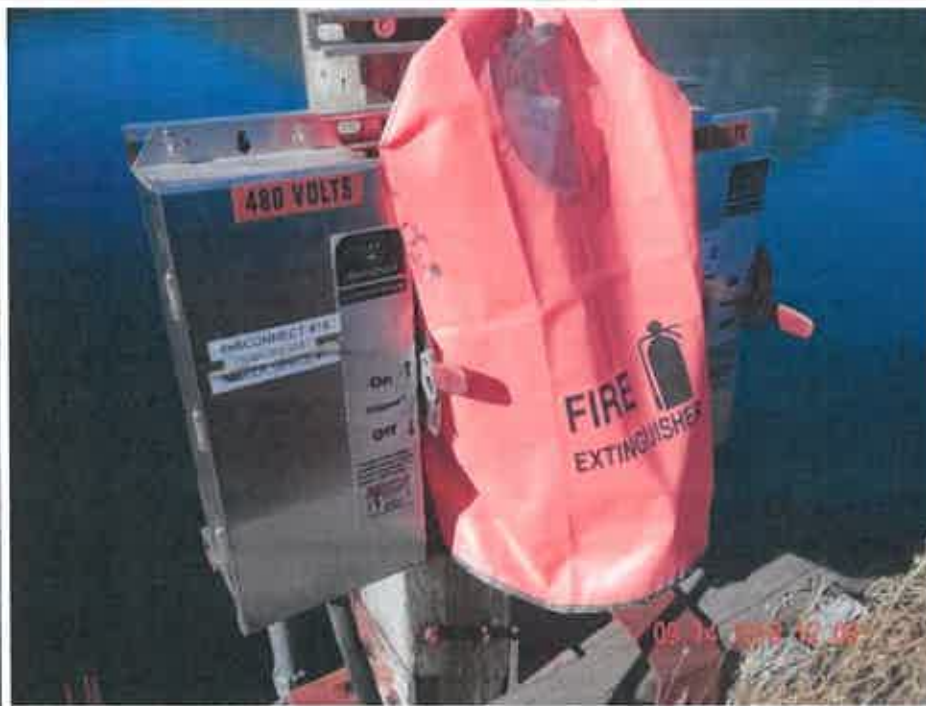
Photo # 30

- Fire extinguishers have been installed since the previous inspection in 2014. At the time the fire standpipe system and monitors appeared abandoned and unserviceable. A total of five (5) new extinguishers were found mainly of the south face of the dock, attached to the light poles (Photo 30).

Typical fire extinguisher on deck.

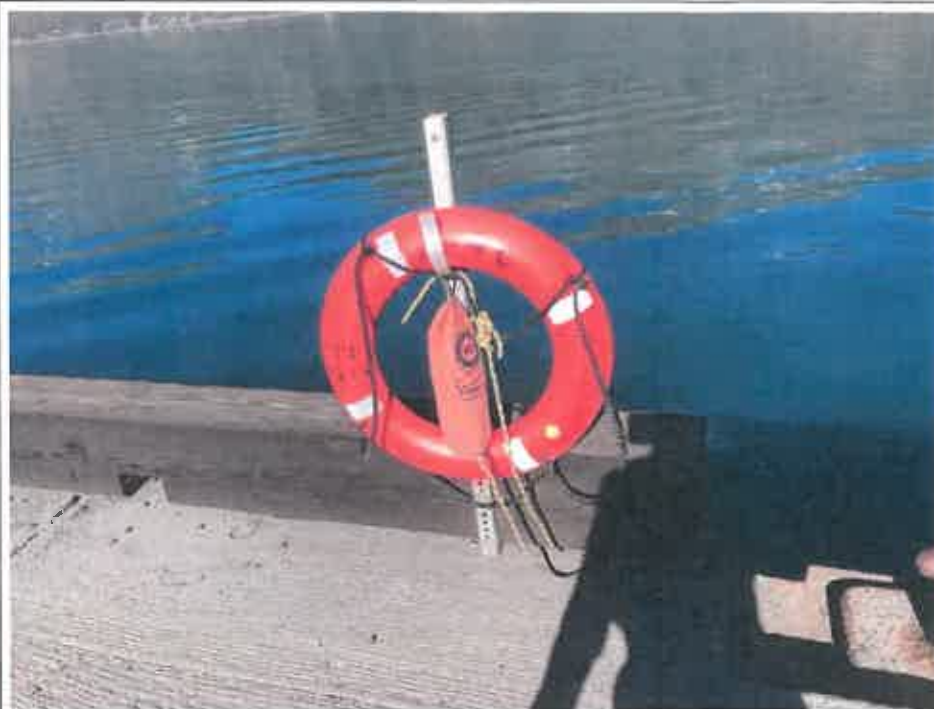
Photo # 31

- Life rings were found in seven (7) locations around the perimeter of the dock (Photo 31). Three (3) new rings were installed as recommended previously.

Typical life ring on deck.

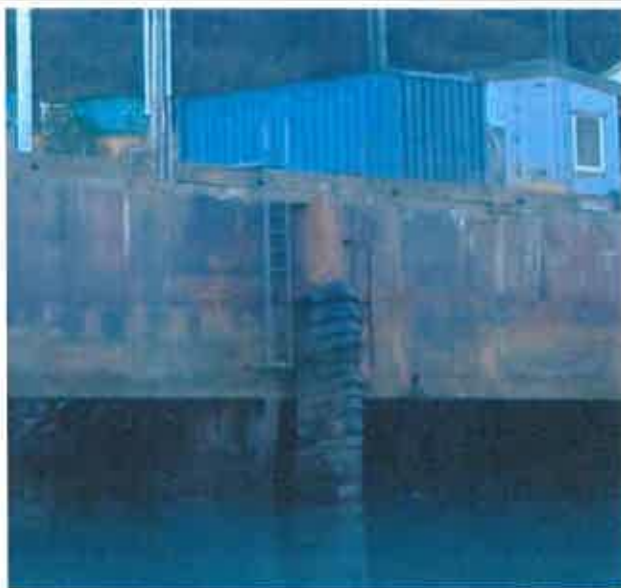
Photo # 32

- Ladders, where identified on the plans, are unserviceable due to damage or are unreachable at low tide. Two (2) ladders require extension below the hull (Photo 32) and one (1) landing grab bar needs to be re-attached to the bullrail (Photo 33). Repairs assume ladder type similar to existing ladders on the dock. However, it is recommended any new ladder to be replaced, including any on berthing faces that are subject to impact should be replaced with modern rubber energy absorbing ladder components.

West barge ladder inaccessible at low tide.

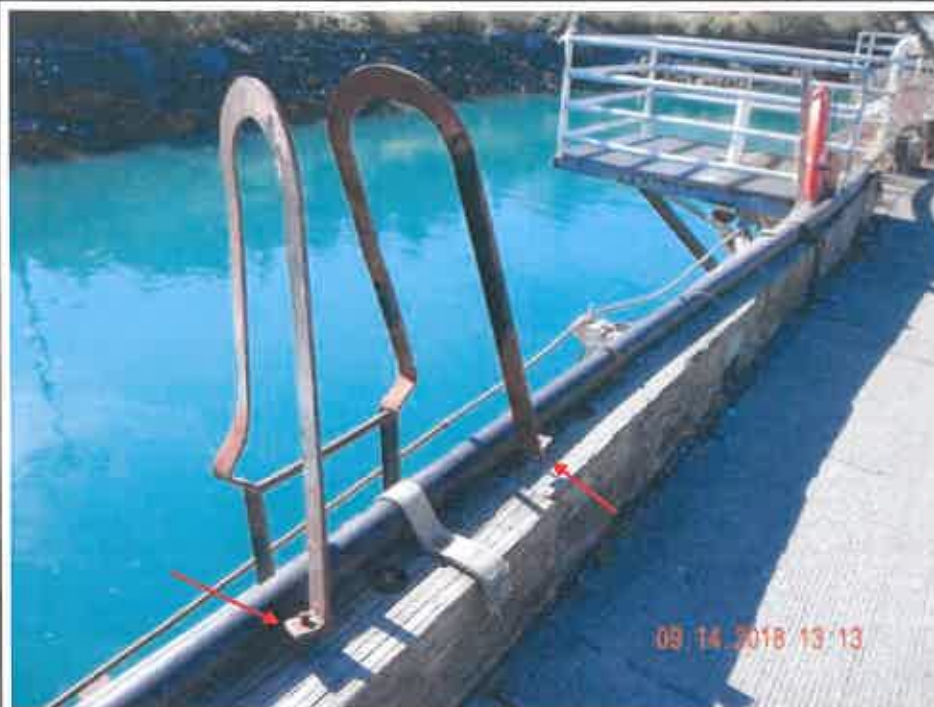
Photo # 33

Landing grab bar detached from bullrail on east barge ladder.

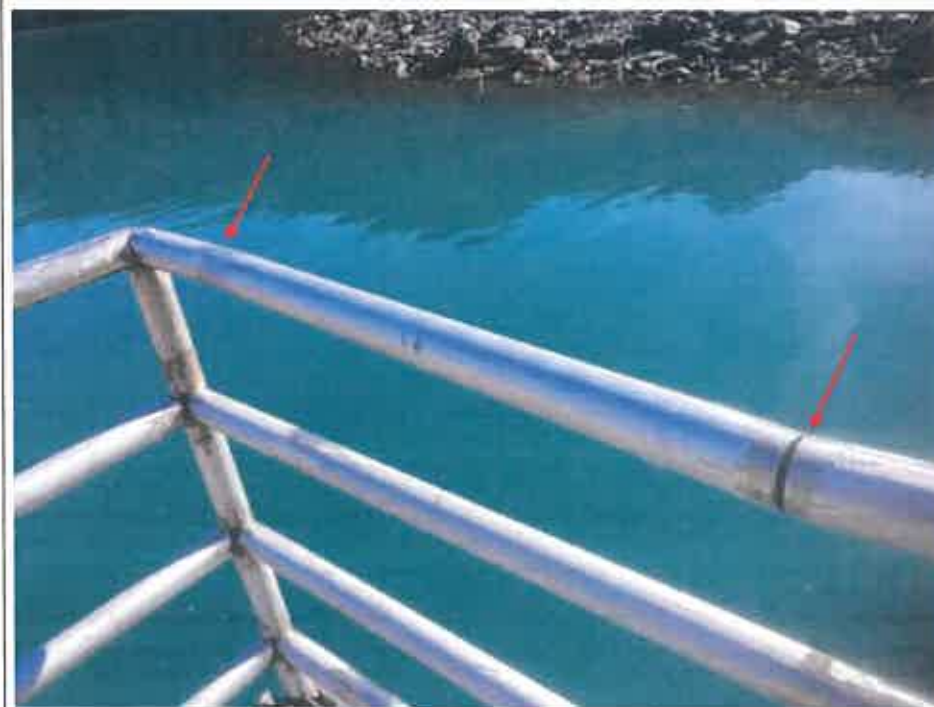
Photo # 34

- Fractures were observed on the hand rails around one of the east barge catwalks (Photo 34). These should be repaired, replaced, or barricaded to minimize safety concerns.

Fractures on handrail on fire standpipe platform.

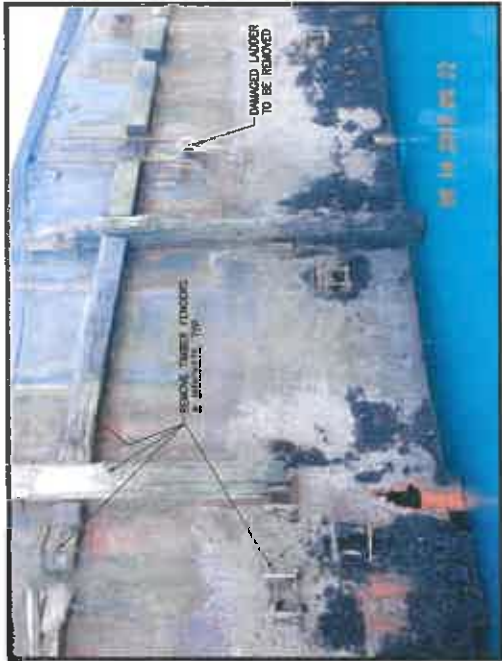
NORTH FENDER SYSTEM - OVERVIEW

- The steel angles are attached directly to the barge hull and provide no energy absorption for vessel impact. The steel angles appear to be remnants of a previous system, most of which is missing. The fenders and attachments are severely deteriorated or missing (Photo 8-9). Much of the fender system is unusable and is recommended to be replaced with a modern energy absorbing system. There are a number of different fender systems available depending on the intended future use. Considering the condition of the overall condition of the dock, anticipated lifespan, and light commercial use, it is recommended a simple floating foam fender be installed.

- NOTES:**
1. REMOVE EXISTING TIMBER FENDERS (~200 LF) AND ANGLE BRACKET ATTACHMENTS (200 EA).
 2. REMOVE DAMAGED OR UNUSABLE LAUNDERS AS DIRECTED BY OWNER.
 3. REATTACH HANGING UTILITY LINE TO BULLBAUL.
 4. INSPECT HULL INTERIOR FOR OPTIMUM LOCATION TO ATTACH ANCHOR BRACKETS.
 5. INSTALL (20) NEW SEAGUARD FENDER AT EQUAL SPACING ALONG NORTH FACE.

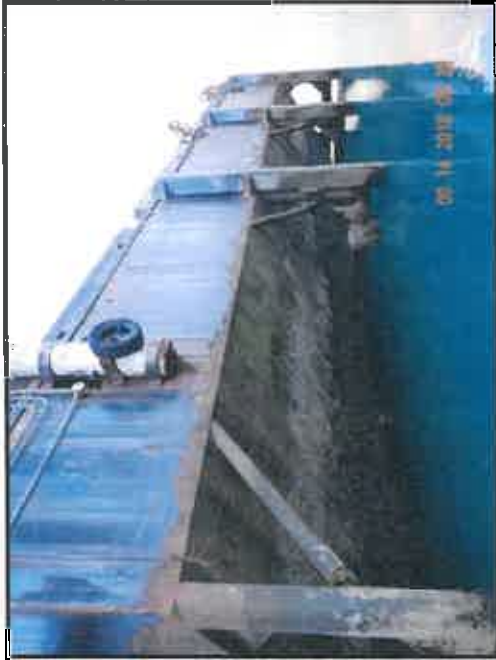
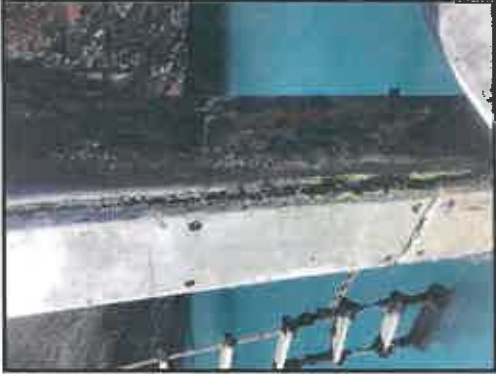
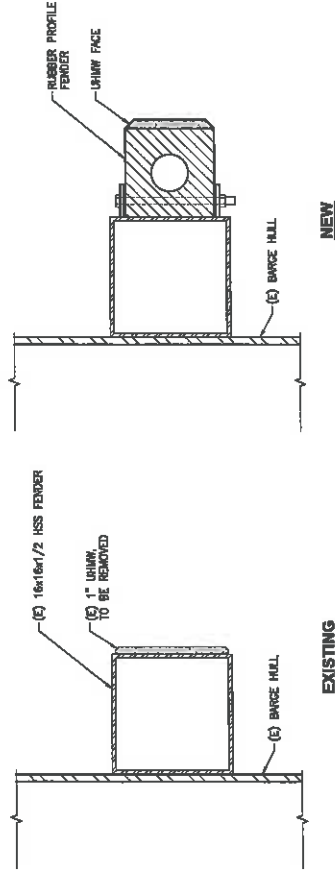
EAST FENDER SYSTEM - OVERVIEW

- These fenders are attached directly to the hull and do not provide any energy absorption under impact. Two (2) of the three (3) HSS members have visible deformation from vessel impact and the light pole on this face has also been damaged (Photo 14). The northernmost HSS was also noted to not have support below the hull where the others are supported by pipe bracing (Photo 15). The narrow width and distance spacing of the fenders are not recommended for smaller vessel mooring or larger vessels as there's no appropriate points of contact on the southern half of the face. If this face is desired for future berthing, at a minimum it is recommended energy absorption rubber fenders be attached the HSS to sustain impact and only vessels that fit within the contact areas of the fenders be moored at this location.

- NOTES:**
1. REMOVE EXISTING UHMW RUBBSTRIP.
 2. CLEAN SURFACE OFF HSS AS NEEDED FOR NEW FENDER.
 3. INSTALL (3) NEW COMPOSITE FENDERS ON TO EXISTING HSS AS DETAILED.
